## Preliminary Engineering Report Anderson Lane Bridge over the Beaverhead River (MDT Bridge # - 02209)

**May 2022**

Prepared for:  
**Beaverhead County**

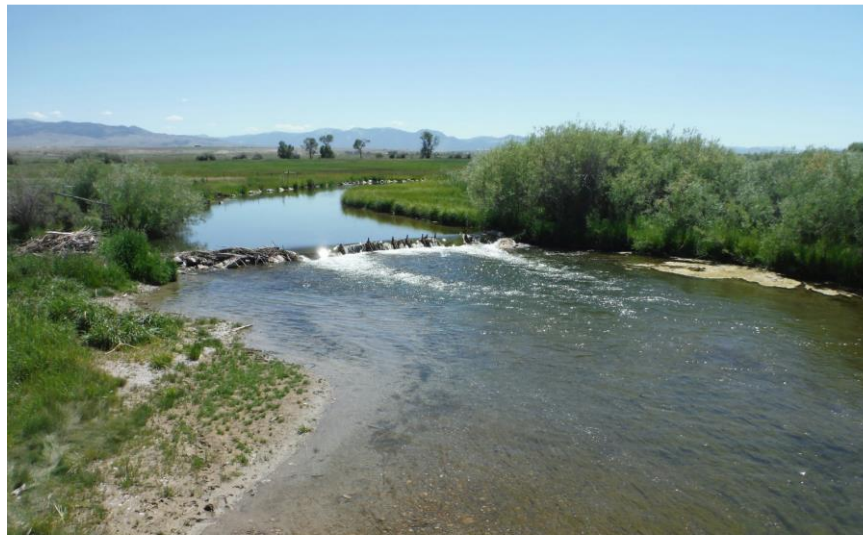
There is an irrigation diversion structure spanning the full width of the Beaverhead River located just upstream of the bridge. This diversion provides flow to the Staudaher – Bishop Ditch and crosses under the existing roadway in a large culvert approximately 65 feet from the east bridge abutment. The water rights for this ditch go back to 1877 and the ditch water is currently utilized for irrigation and stock watering. The diversion is a “pin and plank” style diversion that utilizes boards to control water flow into the headgate.

Figure 2: View of Staudaher – Bishop Diversion (courtesy of MDT)

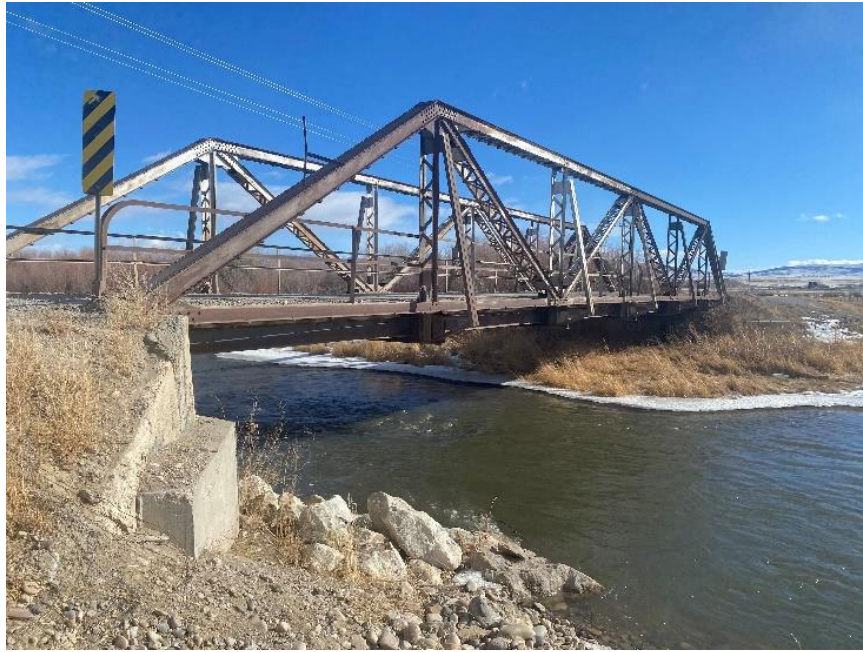
The bridge superstructure consists of a single-span steel riveted Warren pony truss. The truss is 10' tall and is comprised of a variety of "built up" steel members from channel and angle components utilizing riveted steel lattice bracing. The truss floor system consists of transverse steel floor beams (S20x65.4) which are spaced at 16.67' on center. There are seven lines of longitudinal steel stringers (S12x25) spaced at 30" on center which riveted to the floor beams via a steel connection angle. Timber nailers (4" x 6") are through bolted to the top of the stringers to provide support to the deck components. Underside truss bracing is present and consists of steel angles (L3x2.5x1/4"). Truss sway bracing is present and consists of steel angles (L4x3x5/16 and L3x2.5x1/4). The truss has four points of contact at the bearing areas on the concrete abutments aligned under the lower truss chord. The bearings consist of original fixed bearings at Abutment 1 and roller nest (expansion) bearings at Abutment 2.

Figure 4: General view of steel Pony truss superstructure.

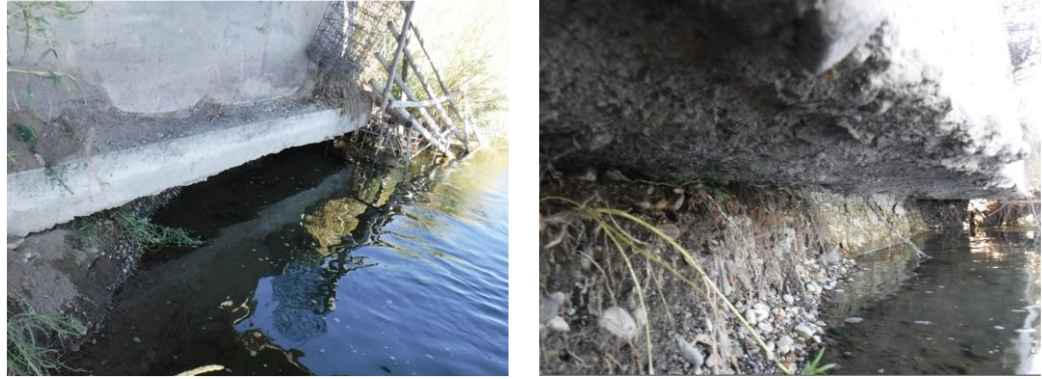
Some noted improvements have occurred since original construction of the bridge in 1924. The largest improvement was replacement of the original deck (assumed to be timber) with a concrete deck. It is unknown the exact date of this replacement, but based on conversations with the County, likely occurred in the 1980's. In 2019, MDT conducted an underwater inspection of the bridge and identified considerable undermining under the north abutment (up to 2' vertical and 2.5' horizontal) and sent a plan of action notification to the County. Beaverhead County crews installed riprap mitigation in this undermining location to help arrest the progress of this material loss.

Figure 5: View of undermined Abutment 1 in 2019 (courtesy of MDT)

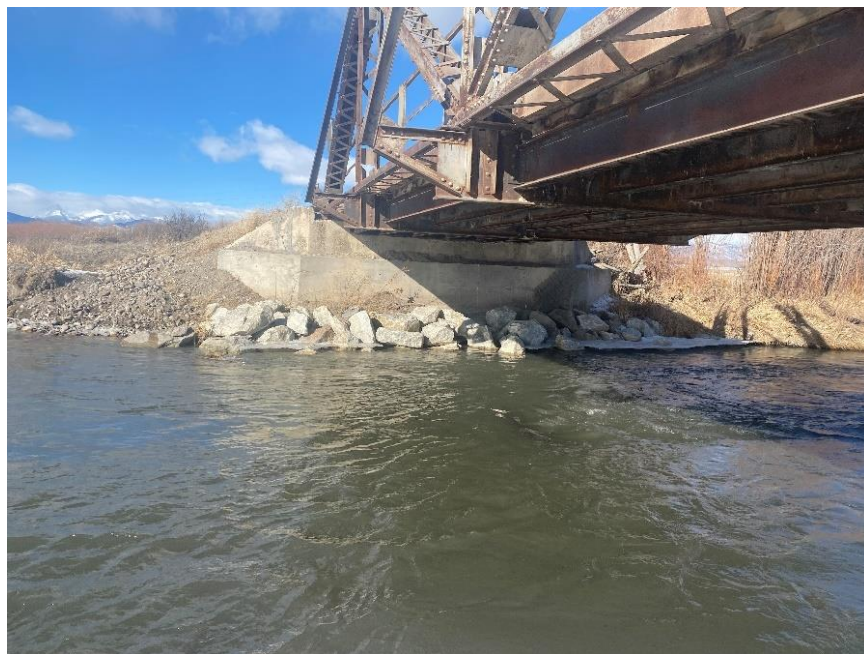
Figure 6: View of mitigated undermining area at Abutment 1 with riprap in 2022.

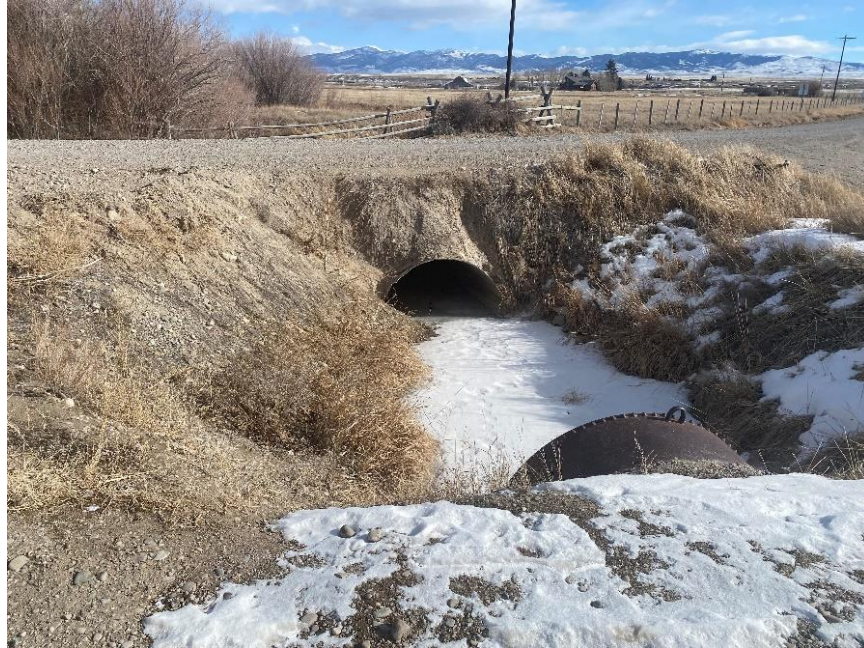
An ancillary crossing of Anderson Lane over the Staudaher – Bishop Ditch, within the improvement area of this structure, is located 60' to the southeast of the existing bridge and consists of an older 6' span corrugated steel pipe. The headgate access road and subsequently informal fishing access crosses over a 6' diameter “boiler pipe” that is attached to the headgate at the start of the Staudaher – Bishop Ditch.

Figure 7: View of corrugated steel pipe crossing for Staudaheer – Bishop Ditch under Anderson Lane. The other pipe in the foreground is the boiler pipe crossing under the access road that is attached to the headgate. Note steepness and roadside safety hazard of the open ditch section.

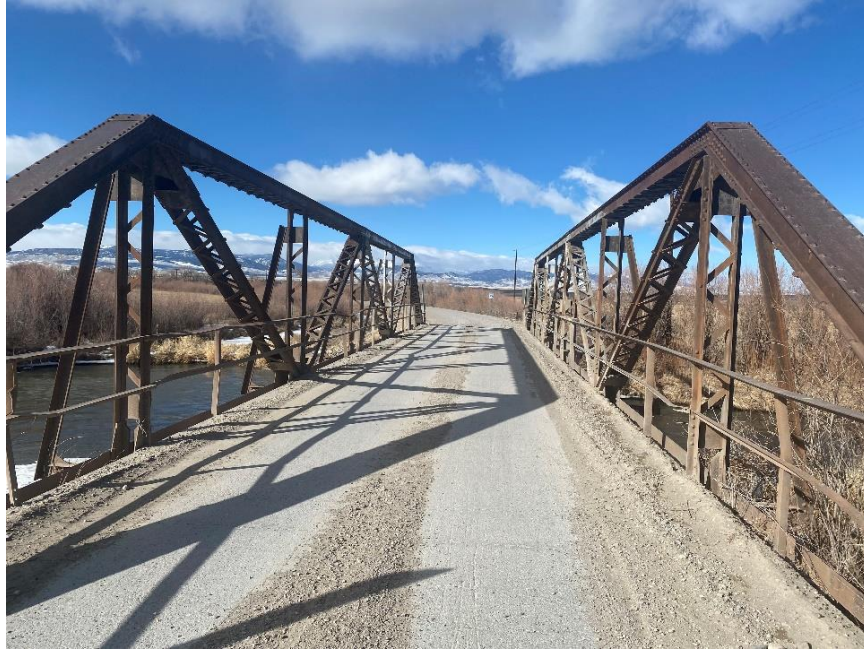
The concrete deck is in fair condition due to transverse cracks at 3' to 4' spacing, surface abrasion at wheel lines and areas of exposed reinforcing near the floor beams on the deck underside. The steel stay-in-place form is heavily corroded with considerable areas of section loss. Earthen material and gravel accumulation has occurred at the bridge edges and centerline.

Figure 8: General view of concrete deck. Note transverse cracking and material build up.

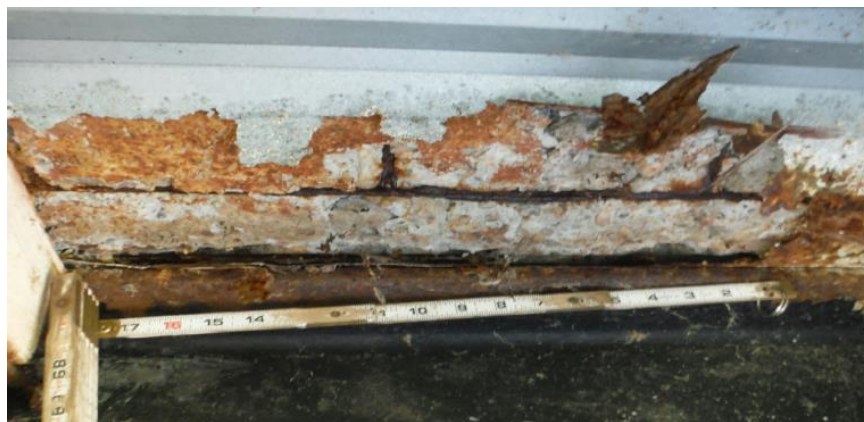
Figure 9: View of deck underside with area of exposed and corroded reinforcement. Note lack of steel stay in place form (courtesy of MDT)

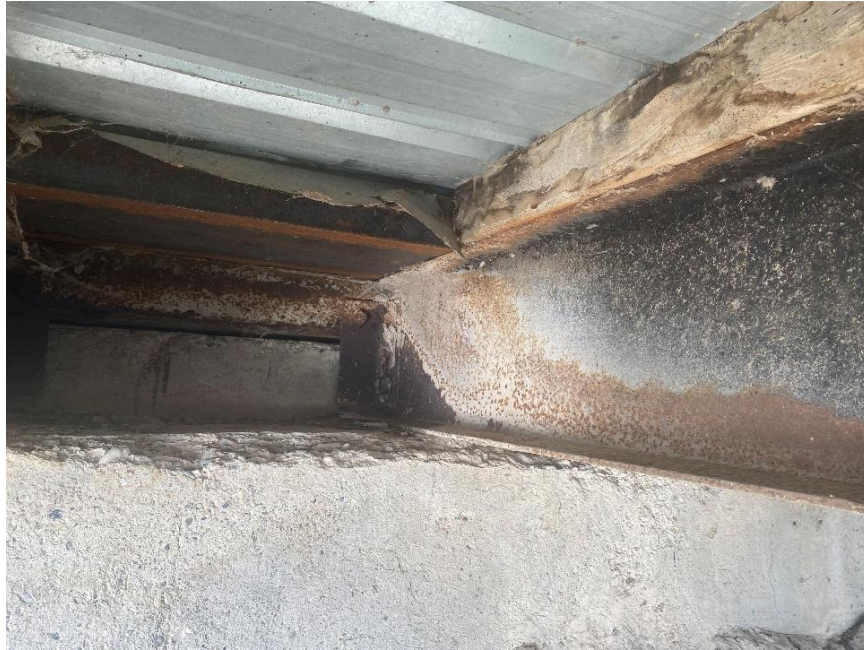
The mass concrete foundation is in fair condition at both abutments. Both abutments exhibit spalling and abrasion along the top portion of the abutment. Abutment 1 exhibits large spalls up to 4" deep along the interface of the bearing seat and face of abutment over the entire abutment length. Abutment 1 also has full height vertical cracks up to 1/16" wide. Abutment 2 exhibits 1/4" wide vertical cracks propagating from the bearing locations. The bridge wingwalls presented considerable vertical and diagonal cracking, up to 1" wide. The undermining that was previously identified in the 2019 underwater inspection at Abutment 1 has been repaired with placed riprap (refer to Section II.B above for more information on undermining and repairs).

Figure 10: Typical view of spalling and abrasion over length of top surface of abutment.

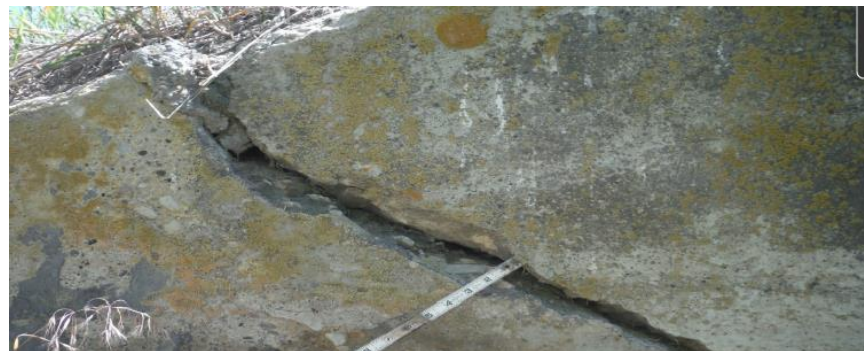
Figure 11: View of 1" wide crack in Abutment 2, north wingwall, typical of wingwall cracking (courtesy of MDT)

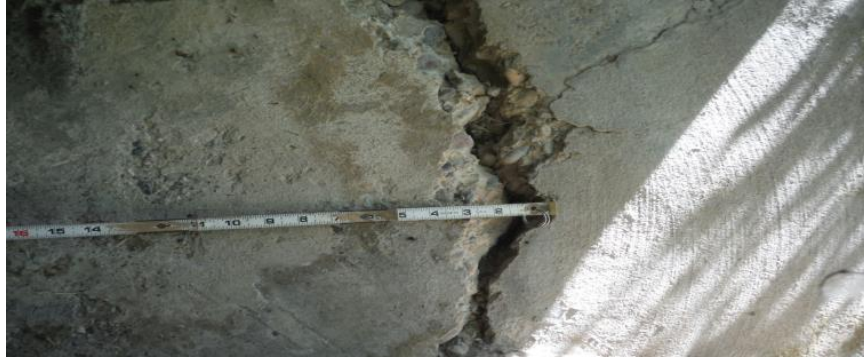
Figure 12: View of Abutment 2 full height vertical cracking up to 1 ½" wide adjacent to the south bearings (courtesy of MDT)

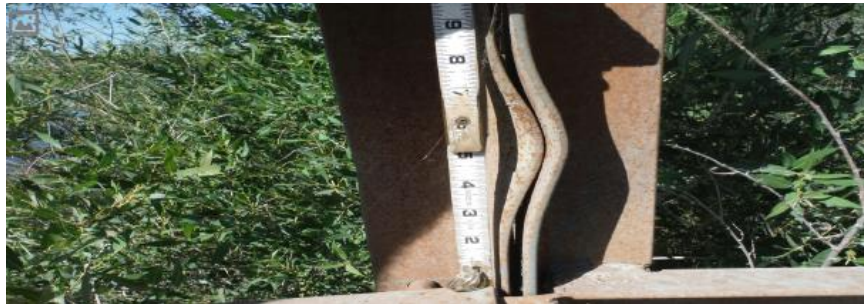
Overall, the superstructure condition is rated as fair – though there are components of the superstructure that are in poor condition. As shown in the most recent MDT inspection report: The primary truss members were in fair condition due to deformation due to traffic impacts causing up to 1" deformation at multiple members on both trusses. The truss members have minor pack rust forming at the lower gussets with coating failure and minor surface corrosion with negligible section loss throughout.

Figure 13: View of 1" distortion in north truss vertical, common in several areas throughout (courtesy of MDT)

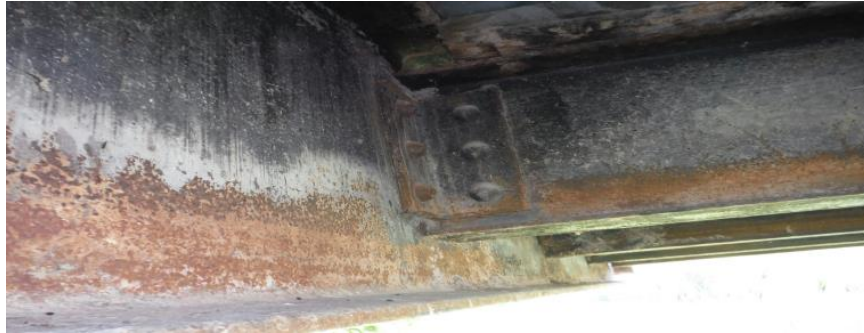
The steel floor beams are in satisfactory condition and exhibit coating failure on the bottom half of the members with minor surface corrosion and negligible section loss.

Figure 14: View of coating failure with corrosion on floorbeam, typical (courtesy of MDT)

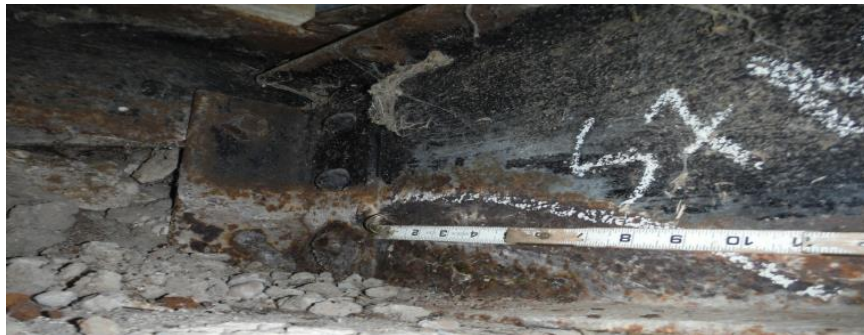
The steel stringers are generally in fair condition with coating failure and minor surface corrosion and negligible section loss. The end stringers typically exhibit minor section loss with 1/16" pitting in the web above the bottom flange and isolated pitting up to 1/8" as well as one location with advanced section loss of the stringer web up to 100% of the web thickness.

Figure 15: View of 100% section loss through web of Stringer 7 at Abutment 2 (courtesy of MDT)

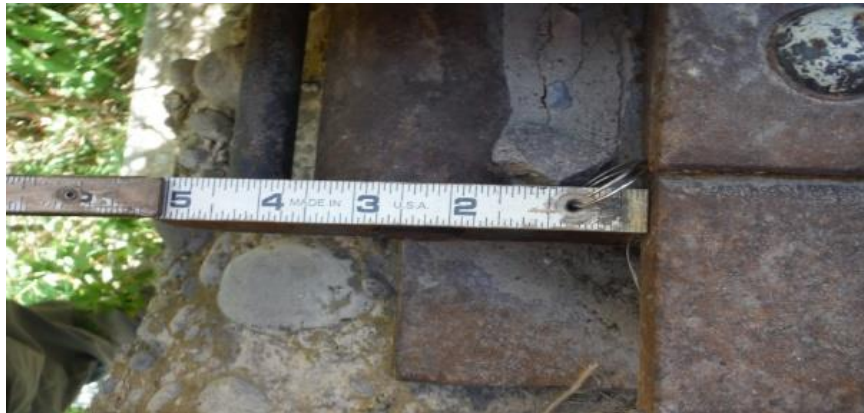
The moveable steel bearings at Abutment 2 were in poor condition and typically had roller nests that were translated in the opposite direction of the expanded bearings beyond the span side limits of the masonry plate with the first roller at the edge of the masonry plate and no longer under the shoe plate. The bearings had isolated areas of coating failure on all surfaces with surface corrosion and pitting up to 1/16". The steel fixed bearings at Abutment 1 were in poor condition with the bearings partially being pushed off the back of the abutments and rotating into the embankment fill with loss of bearing and bent anchor rods, and typically

had isolated areas of coating failure with minor surface corrosion and up to 1/16" section loss.

Figure 16: View of the south expansion bearing – roller nest extending 2 1/2" past masonry bearing plate (courtesy of MDT)

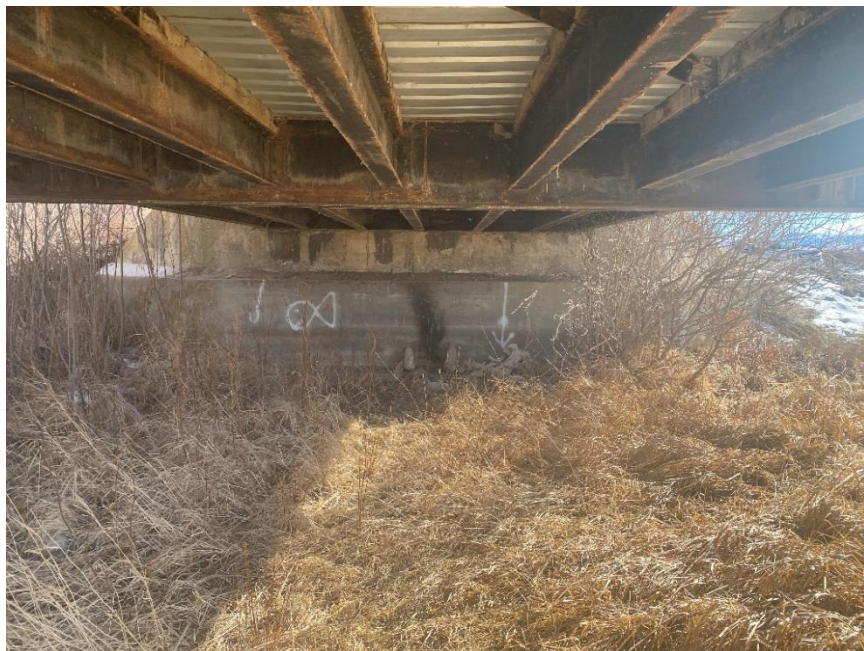
It is estimated that 40% of the superstructure components exhibited coating failure with minor surface corrosion typical in these areas.

Figure 17: General view of bridge underside, note coating failures typical.

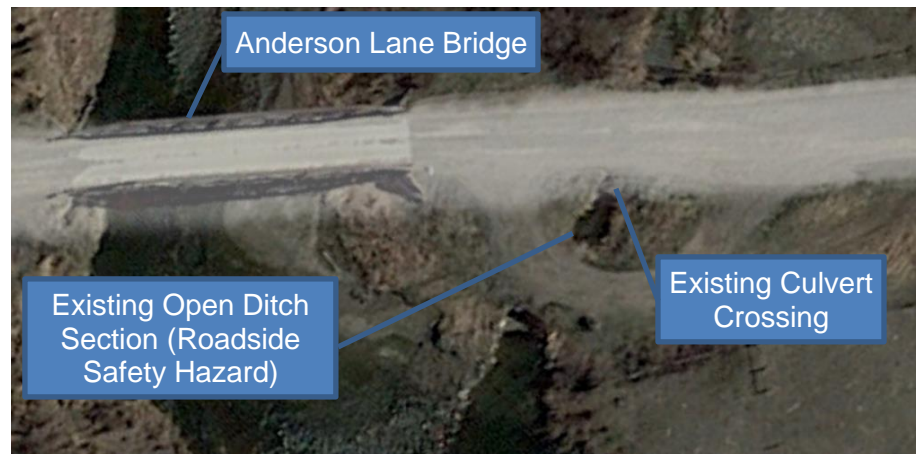
Anderson Lane crosses the Staudaheer-Bishop Ditch about 60' southeast of the existing bridge in a 6' steel culvert and will need to be replaced as

Figure 18: View of Staudaheer-Bishop Ditch crossing location

part of this project due to the increase in road elevation and poor condition of the existing crossing. Additionally, the pipe will be lengthened to attach to the headgate at the diversion structure. This will allow the existing open ditch section, which is a roadside safety hazard (shown in the aerial image below) to be covered. Improvements to the headgate are out of the scope of this project as are improvements to the diversion structure itself, though it has been noted that the elevation of the existing culvert crossing is too high and should be lowered to allow the diversion structure to function better (with less backwater).

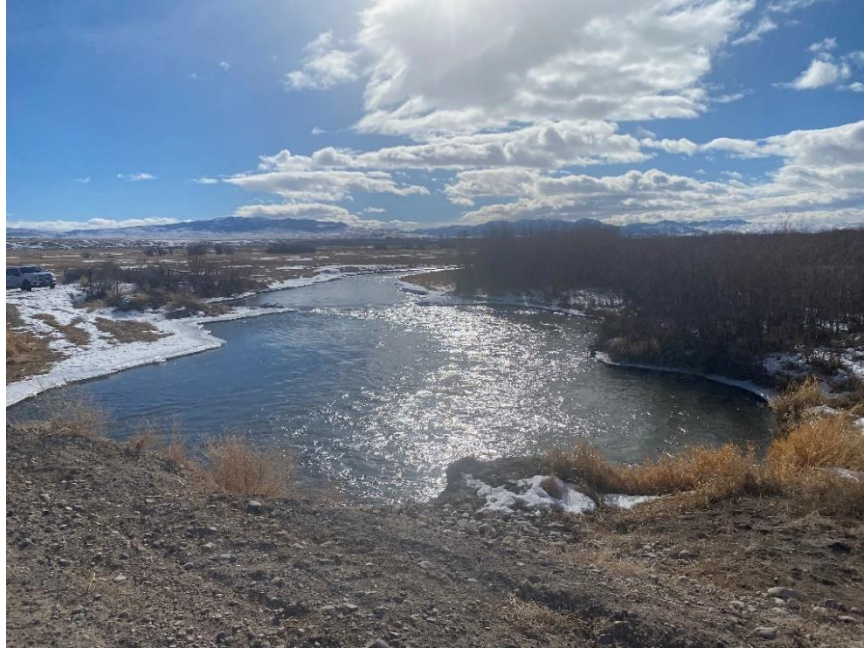
The Beaverhead River channel in the bridge vicinity is in fair condition, with poor channel alignment through the bridge caused by a bend in the channel at the bridge location, which has resulted in scour and undermining at Abutment 1, which has previously been discussed. Abutment protection was added in 2020 to Abutment 1 as a result of the undermining. No other abutment protection is present at the bridge. The private landowner located upstream of the structure has installed riprap bank protection on the southeast bank.

Figure 19: View of the Beaverhead River upstream of the bridge. Note diversion structure and flow impacting north riverbank.

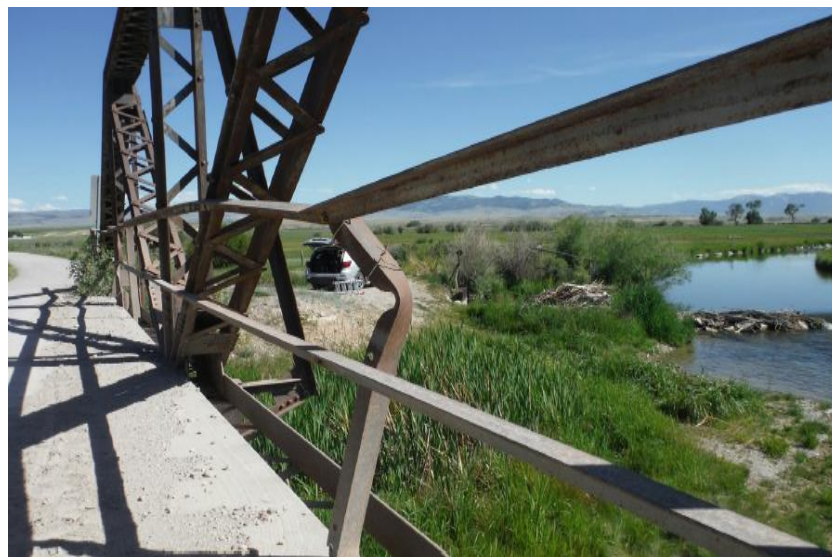
The current bridge rail configuration is substandard steel rail connected to truss vertical elements and appear original to the 1924 bridge. Because of this, impacts could be sustained directly on the steel trusses, which could lead to catastrophic failure of the entire bridge due to the superstructure being classified as fracture critical. The steel rail and primary truss members have considerable collision and impact damage, which have created locations of distortion and tears in the steel

Figure 20: View of substandard original bridge rail, with area of damage (Courtest of MDT)
